Rainwater Management Performance of Newly Constructed Residential Building Enclosures During August and September 2004

Prepared for the Home Builders Association of Metro Orlando and the Florida Home Builders Association By:

Joseph William Lstiburek, Ph.D., P.Eng.
Building Science Corporation
70 Main Street
Westford, MA
01886

January 11, 2005

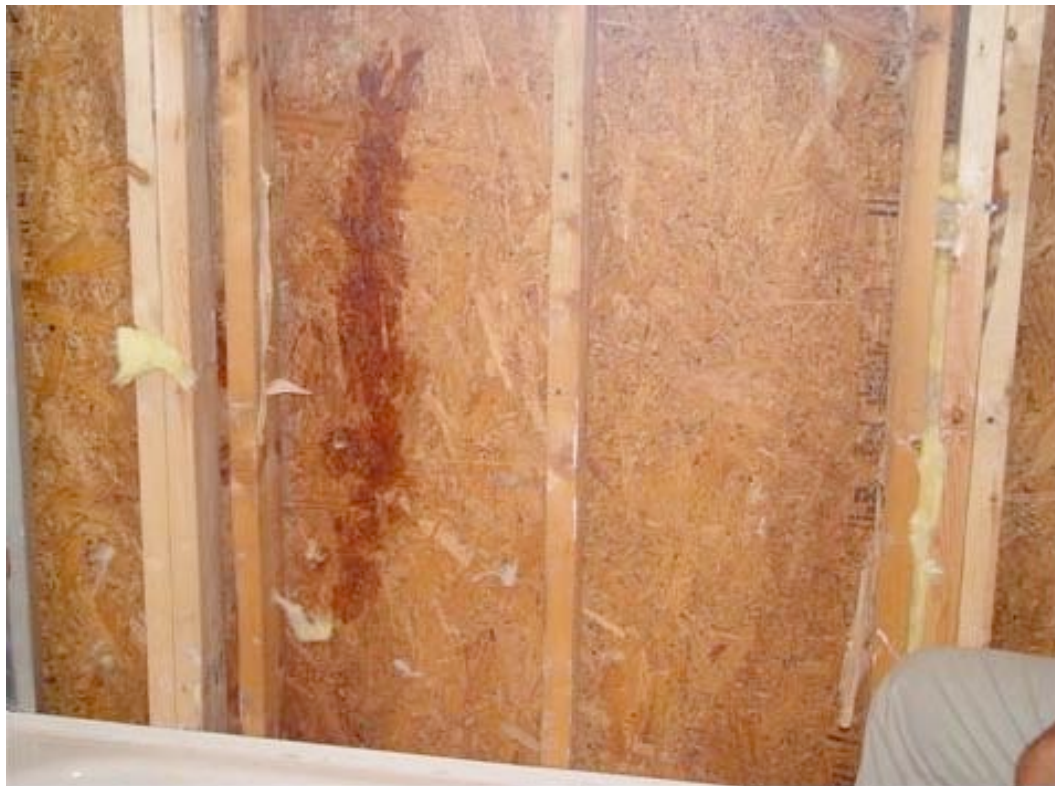
Photograph 2: Rainwater Entry into Second Floor Frame Assembly

In the second floor frame assemblies water also penetrated the stucco via micro cracks. Again, as previously mentioned, typical paint finishes are unable to span micro cracks. In frame wall assemblies it is expected that this penetrating water will be drained back to the exterior. However, in many cases the penetrating rainwater was not drained to the exterior due to adhesion between WRB's and the stucco renderings preventing drainage between the stucco renderings and WRB's, a loss of water repellency of the WRB's and the lack of effective flashing at the base of the drained assemblies.

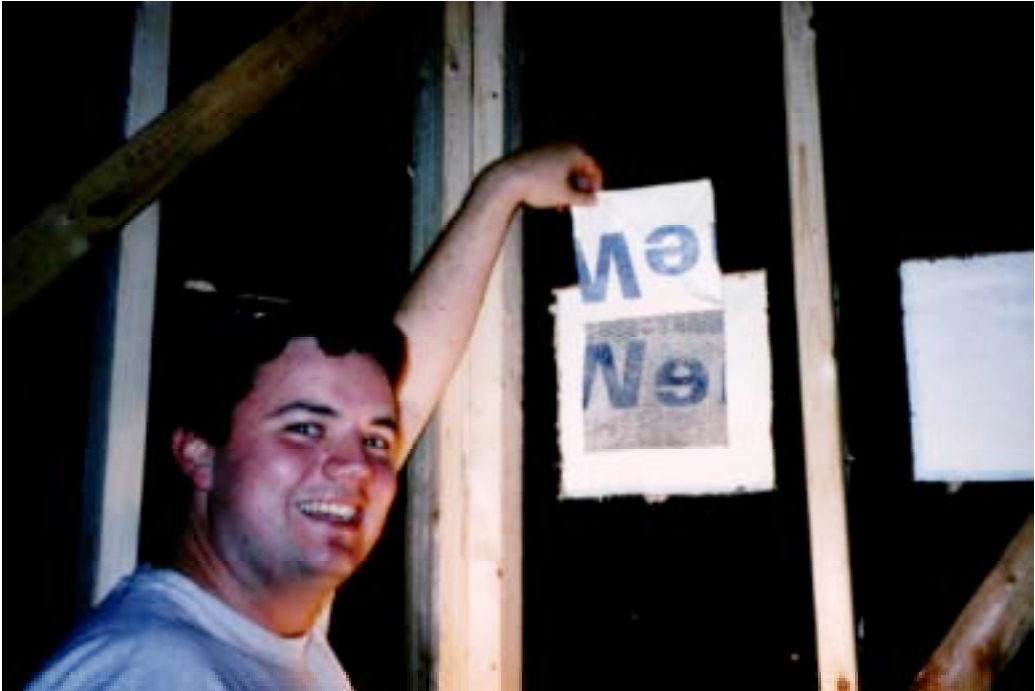
Photograph 4: Stucco Rendering Bonding to Plastic Housewrap

There appear to be significant performance issues with WRB's relating to manufacture, testing and approval. All plastic housewraps and some building papers tend to bond to stucco renderings thereby negating drainage (Photograph 3). Additionally, many plastic housewraps lose their water repellency (Figure 9) when in contact with sheathing and stucco renderings (Photograph 4).

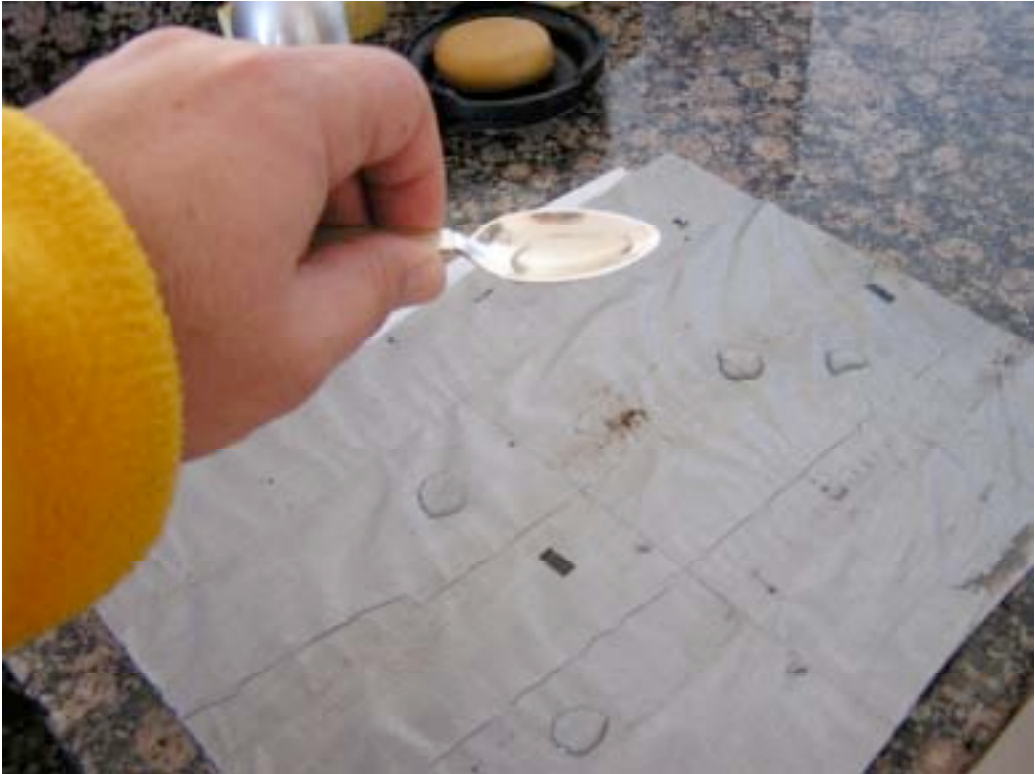
Photograph 5: Water Drop Test For Water Repellency

All perforated plastic housewraps fail a simple test for water repellency and water holdout (Photograph 5 and Photograph 6). Many non perforated housewraps fail a similar test when exposed to surfactants (Photograph 7, Photograph 8 and Photograph 9).

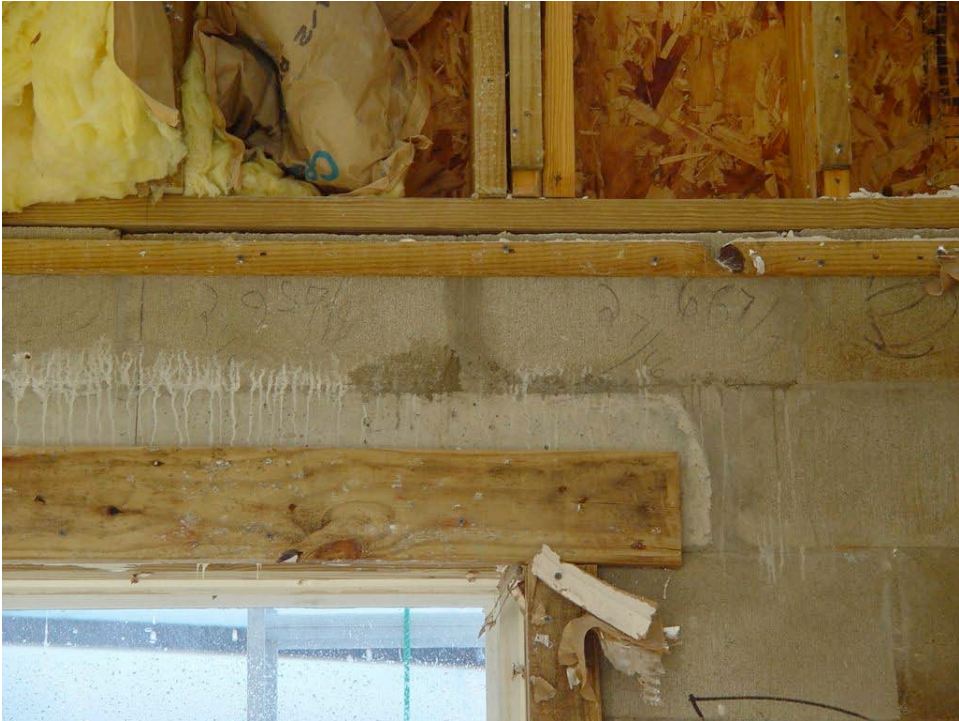
Photograph 17: Water Entry Between Floors

This practice results in leaks during wind driven rain events (Photograph 17) as the moisture storage capacity of the frame wall assembly is easily overwhelmed in the absence of drainage. The second floor frame assembly, which is a drained assembly is effectively unable to drain anywhere except to the interior.

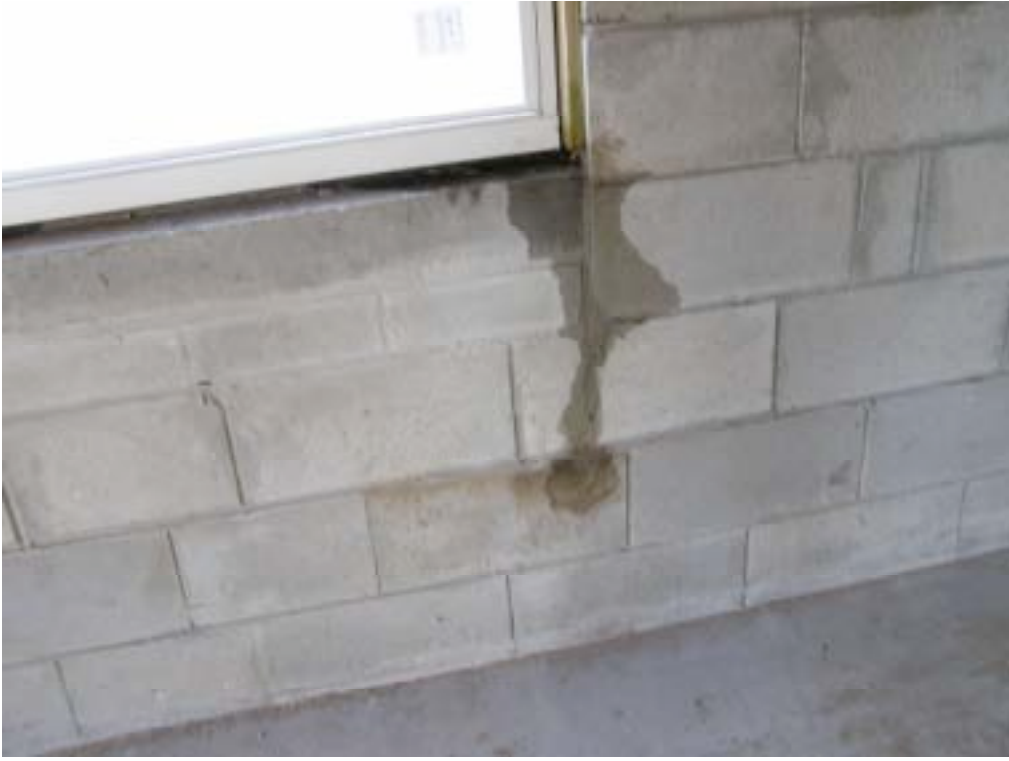
Photograph 24: Window Corner Leakage

However, our testing indicates that many windows leaked at conditions well below their rated value – i.e. under no wind condition (Photograph 24 and Photograph 25).

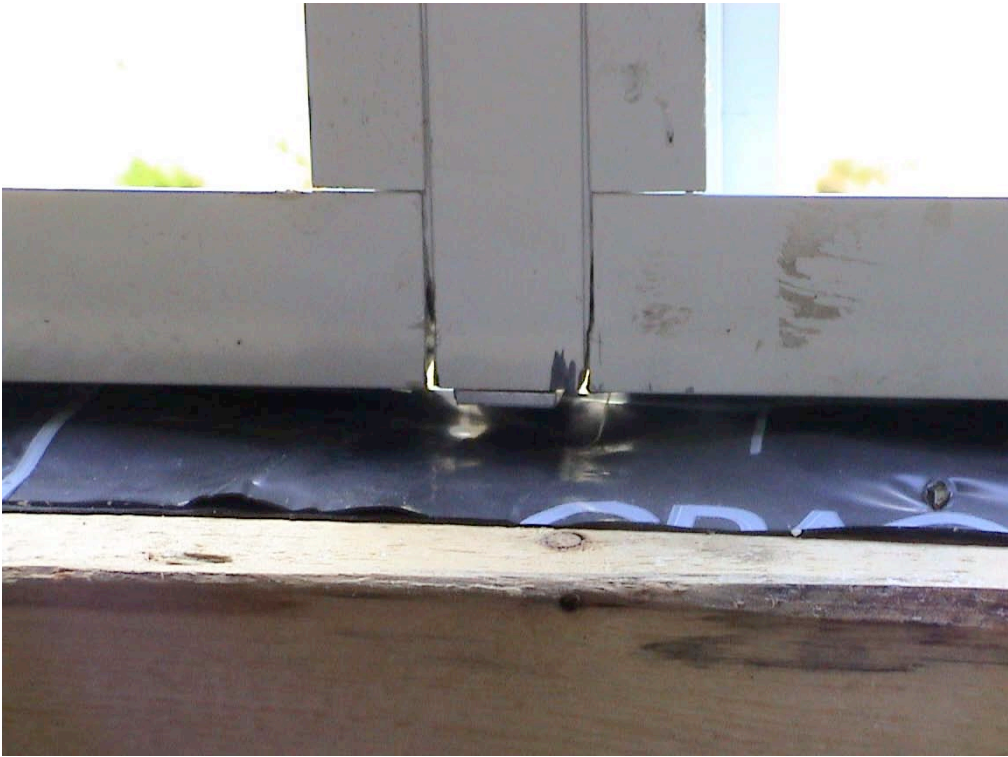
Photograph 26: Mulled Window Unit Leakage Paths

Additionally, many windows are sold as “mulled” or double windows or composite windows. However, they are tested as single units. Every mulled window unit tested leaked with no applied wind load (Photograph 26).

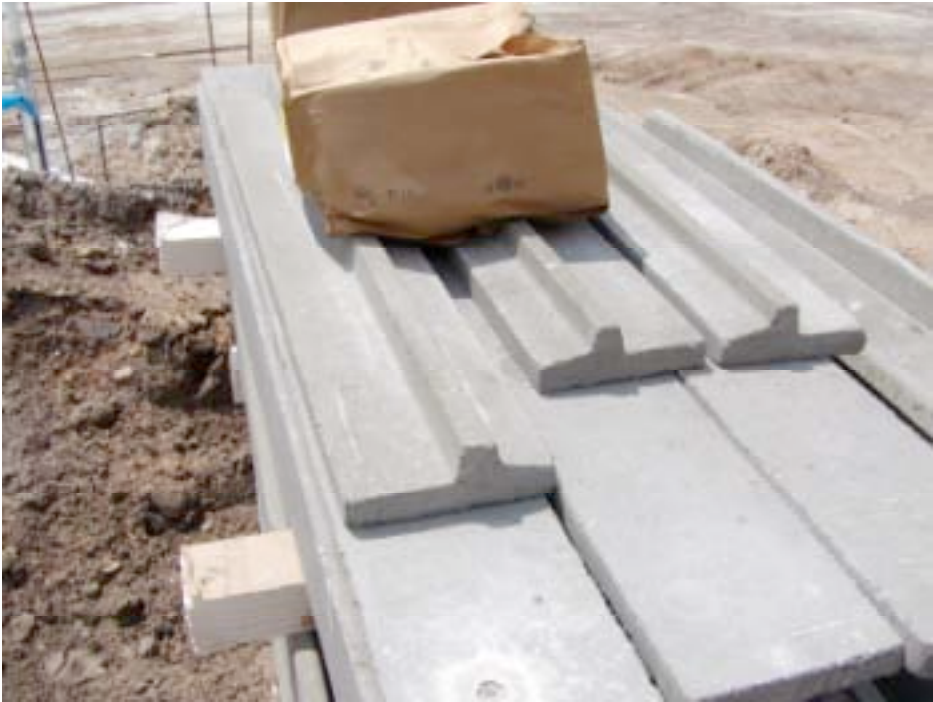
Photograph 27: Precast Sill With Illogical Attachment Rib

Many mass wall assembly window openings are constructed with precast sill units that have a raised rib attachment that directs window water leakage inwards rather than outwards (Photograph 27, Photograph 28, and Figure 13).

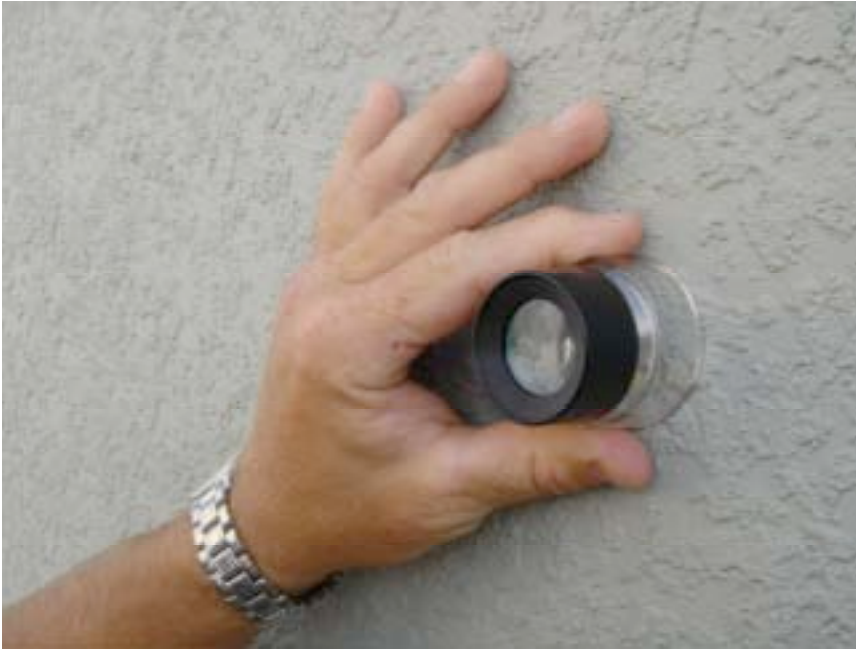
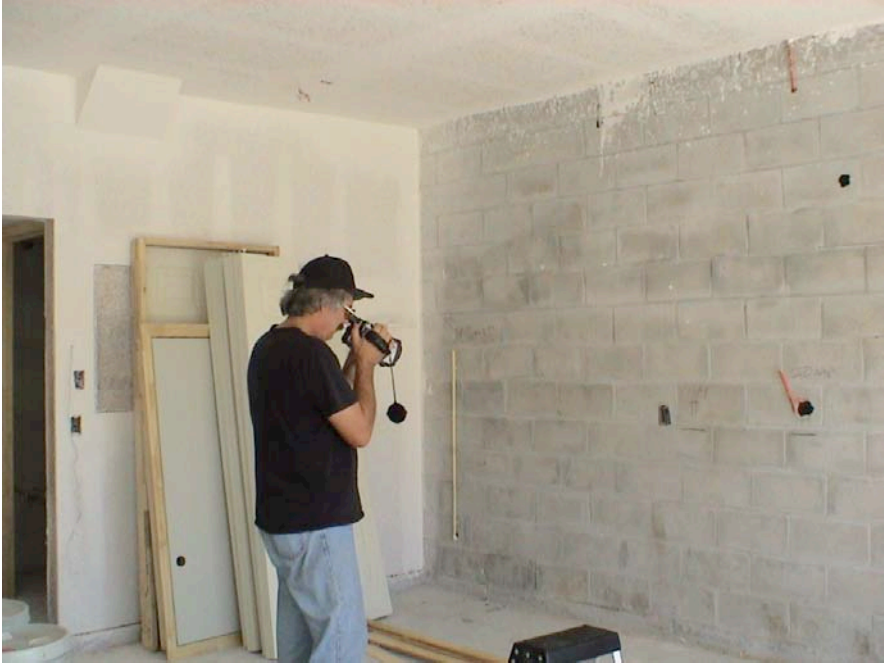
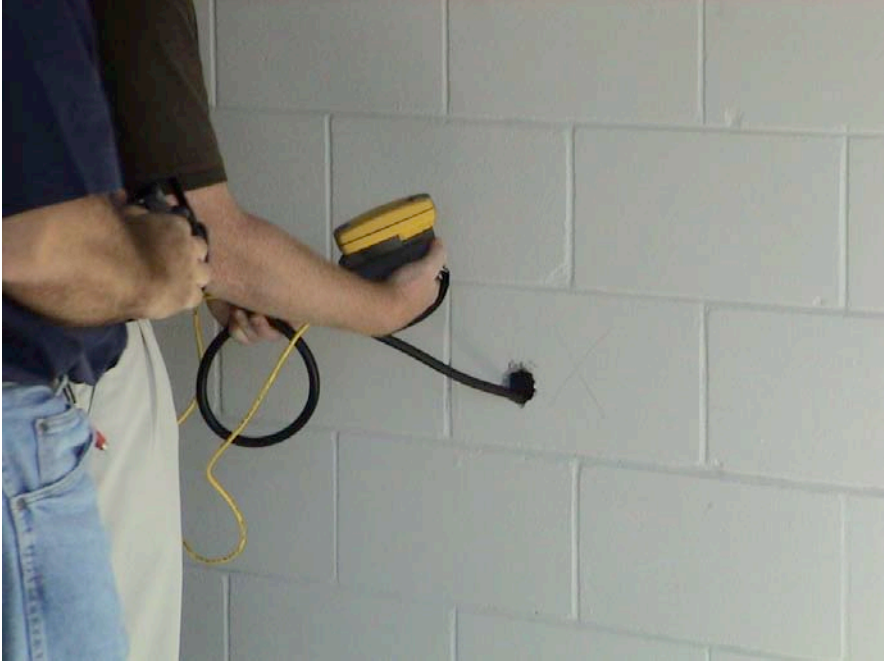
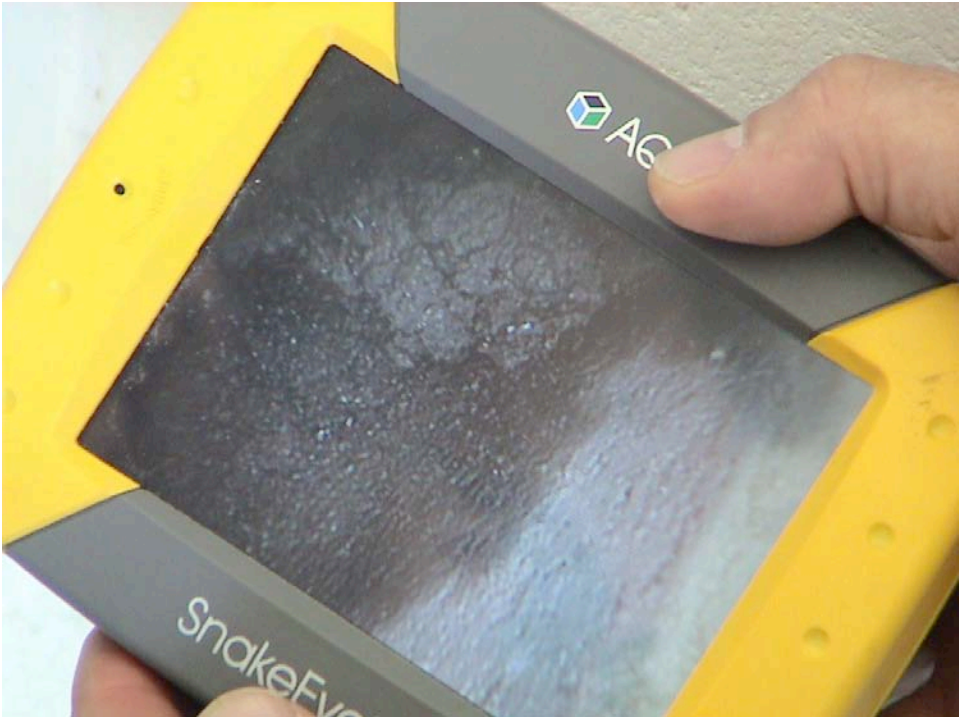
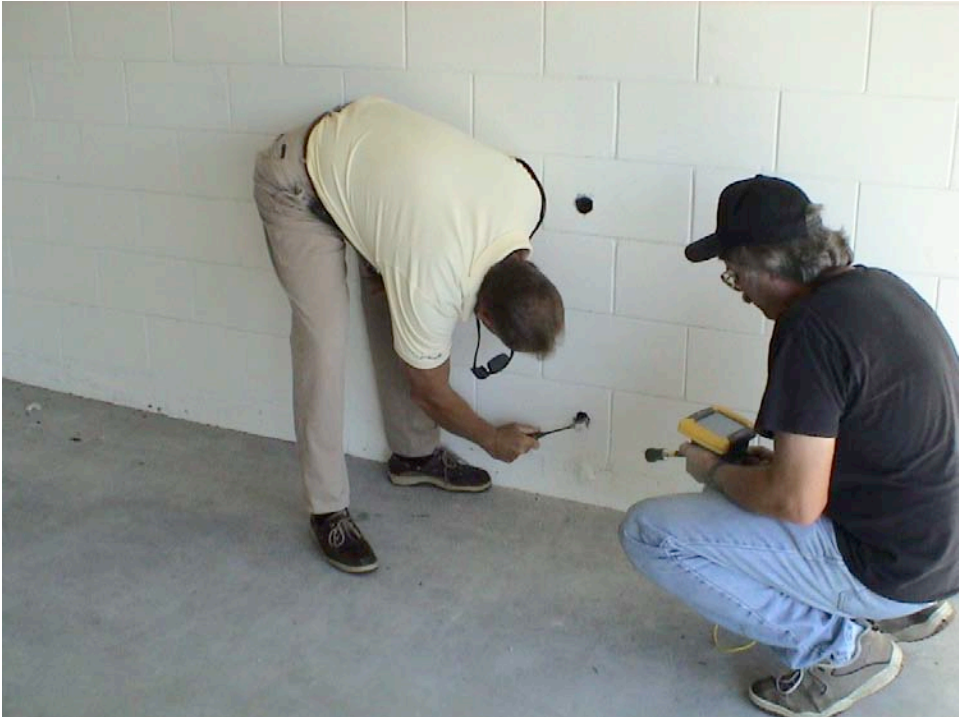
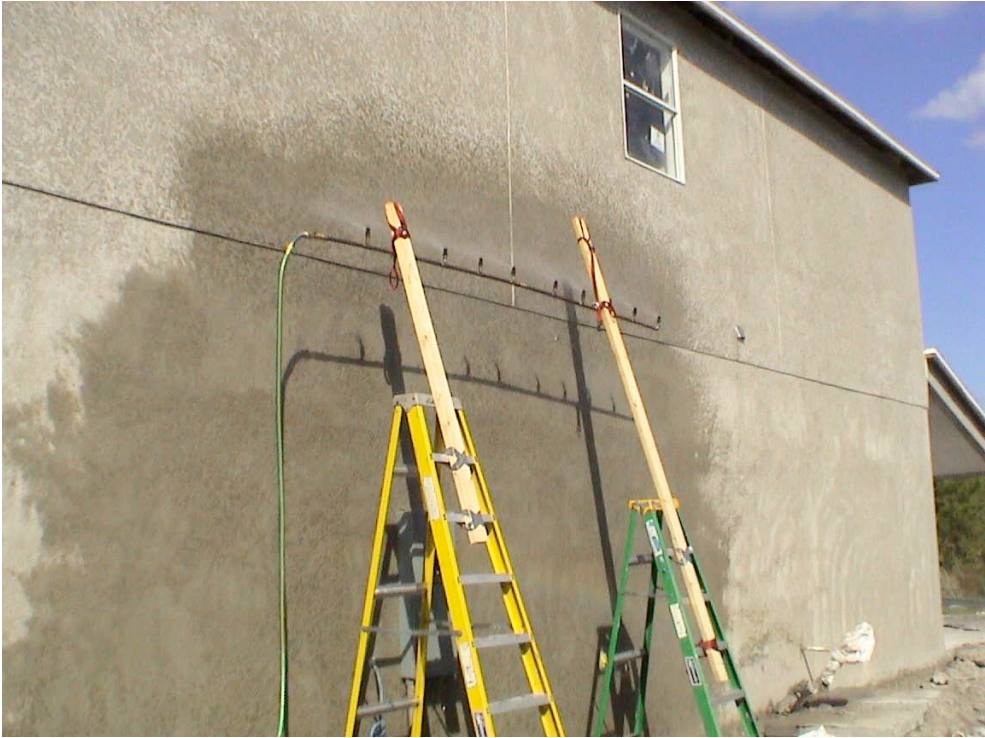
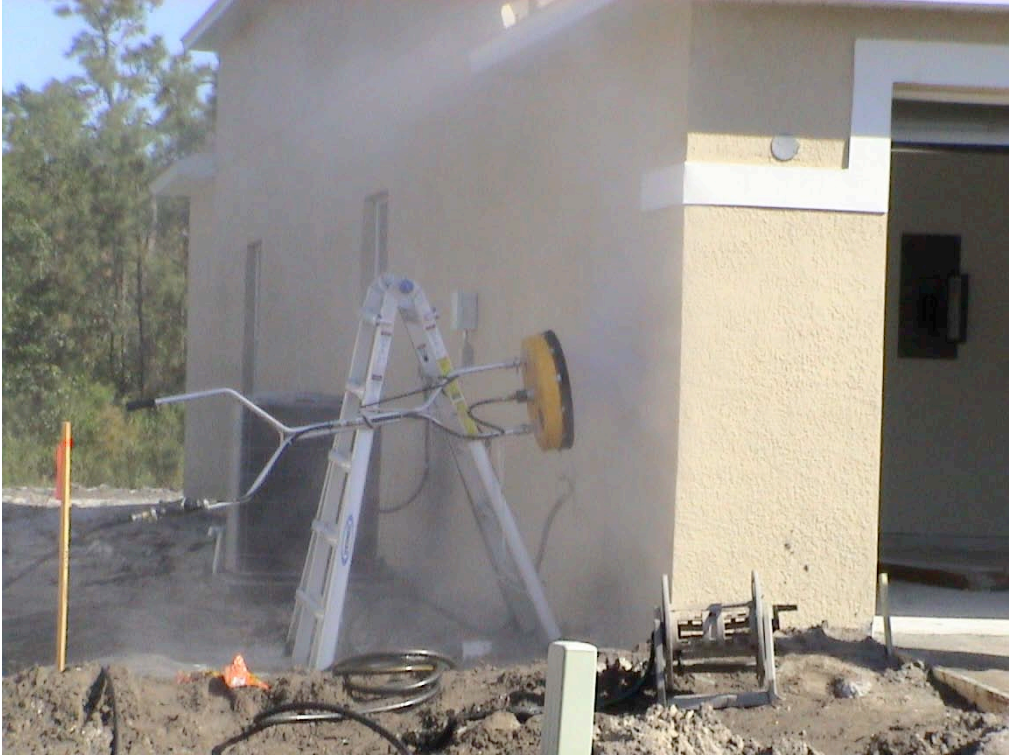
Water leakage testing of stucco renderings was conducted using numerous methods. These methods are memorialized in Photograph 42, Photograph 43, Photograph 44, Photograph 45, Photograph 46, Photograph 47, Photograph 48 and Photograph 49.

The most useful method proved to be the use of a camera probe and a portable spray rack without the application of a pressure difference – either air or hydrostatic.

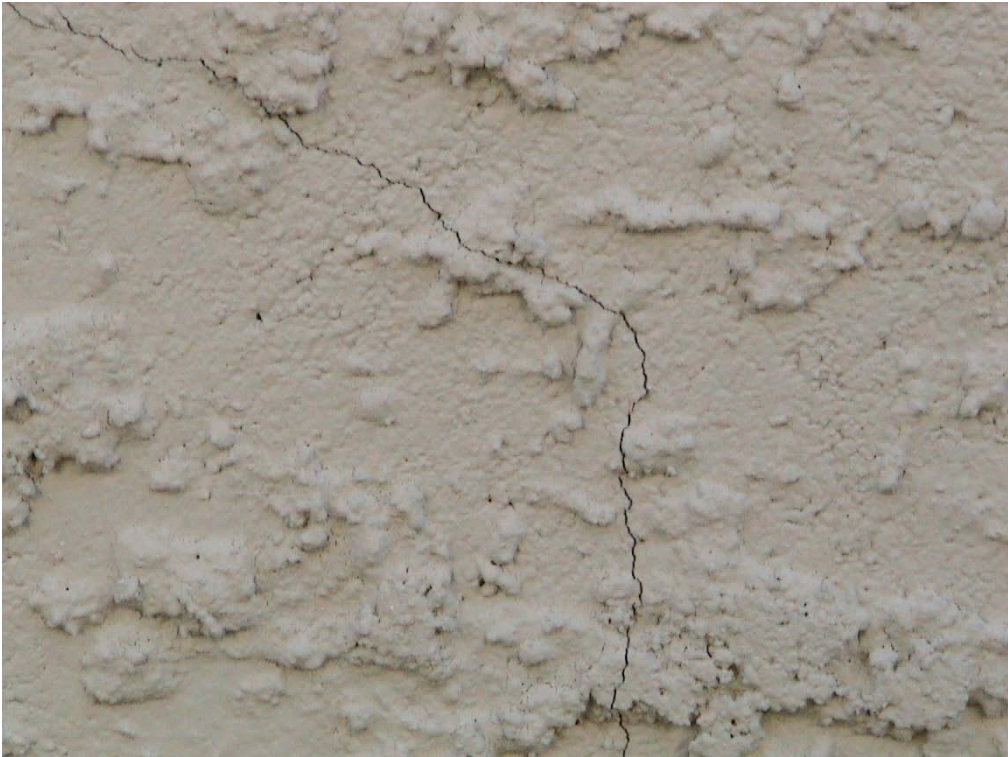
Photograph 60: Typical Crack In Stucco Rendering

However, the presence of cracks (Photograph 60 and Photograph 61) caused all mass wall assemblies to pass water.

The type of crack shown in Photograph 60 is indicative of typical and expected stucco rendering crackage. Workmanship, quality control and cure impact the number and extent of shrinkage cracking. Soil conditions, the nature of the materials, geometry and aspect ratio of mass wall assemblies impact the number and extent of settlement cracking. However, the nature of stucco application, materials and substrates make it impossible to construct crack free monolithic stucco renderings – in other words shrinkage cracks and settlement cracks are to be expected.

These shrinkage cracks and settlement cracks traditionally are handled through ongoing maintenance. At present, technology offers no other practical approach.

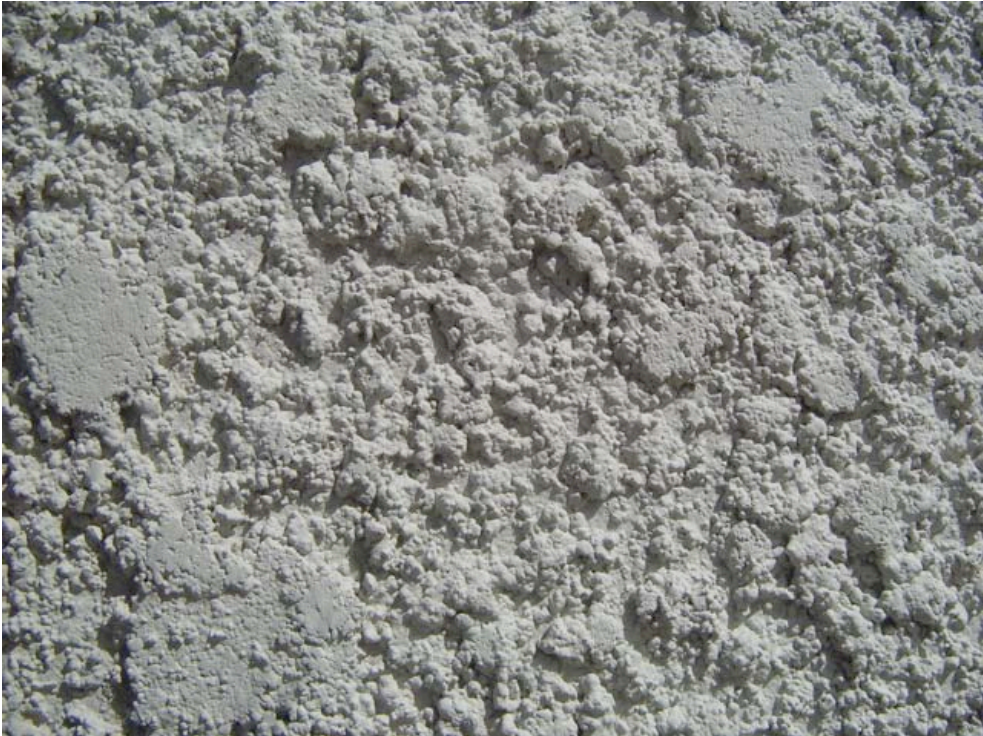
Photograph 66: Paint Coating Over Rough Surface

Low build and high build paint system on both smooth and textured surfaces were carefully examined (Photograph 66, Photograph 67 and Photograph 68) and it is our conclusion that almost no coating or painting system is able to span settlement cracks (Photograph 69). Only small hairline cracks on relatively smooth, and relatively untextured surfaces are there likely to be significant performance benefits of high build systems.
