# Demonstration Assessment of Light-Emitting Diode (LED) Retrofit Lamps

***Host Site: InterContinental Hotel,  
San Francisco, CA***

**Final Report prepared in support of the  
U.S. DOE Solid-State Lighting  
Technology Demonstration GATEWAY Program**

November 2010

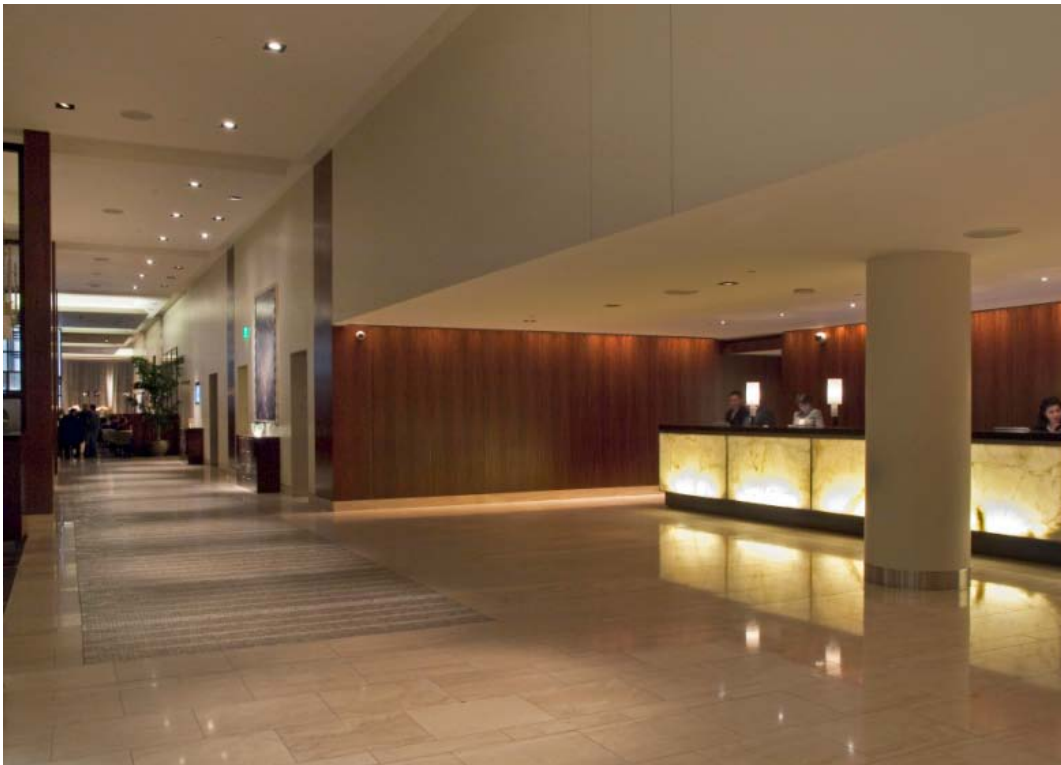
**Figure 1.1.** Photo of InterContinental Hotel Lobby with Original Halogen Lamping in Registration Desk Area. A complete relamping of halogen lamps was carried out to ensure optimum light output. [www.kenricephoto.com](http://www.kenricephoto.com)

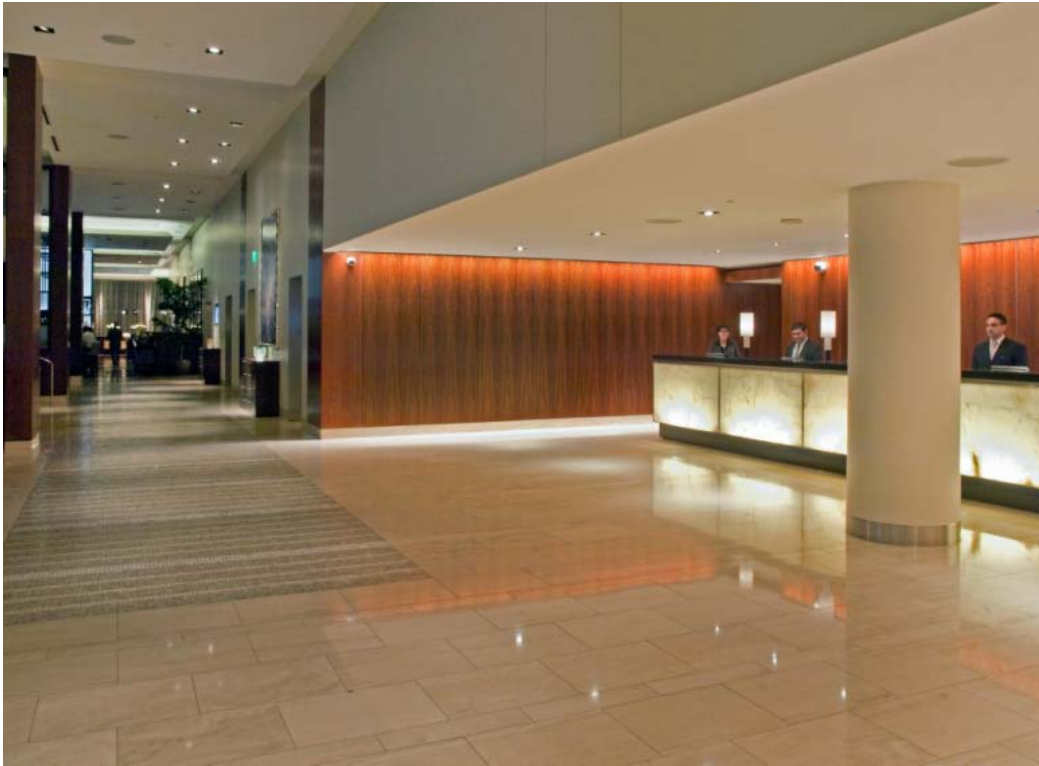
**Figure 1.2.** Photo of InterContinental Hotel Lobby Registration Desk Area with LED Replacement Lamps. [www.kenricephoto.com](http://www.kenricephoto.com)

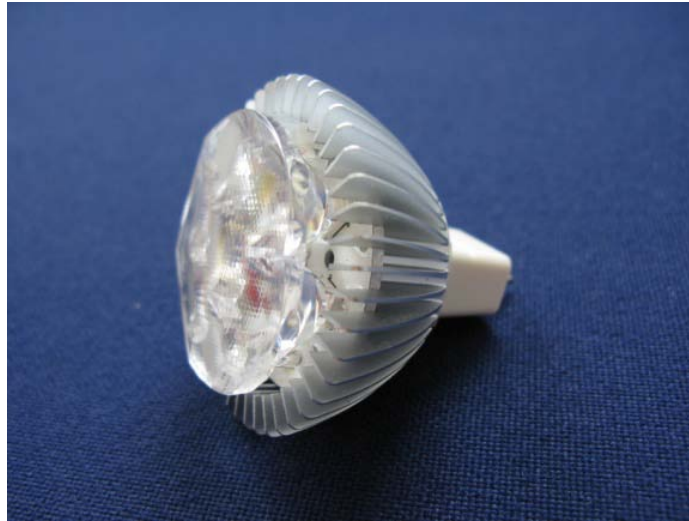
**Figure 2.1.** CRS Electronics 6W LED MR16 Lamp

The track was powered through a triac incandescent dimmer, so the team was able to observe the lamp behavior under dimming. All but the CRS lamp exhibited erratic behavior when dimmed, either dimming unevenly, shutting off below a set dimming point, or producing noticeable flicker. The CRS lamp dimmed smoothly, down to a very low level (measured at less than 10% output) before switching off, appearing to maintain color quality throughout the range.

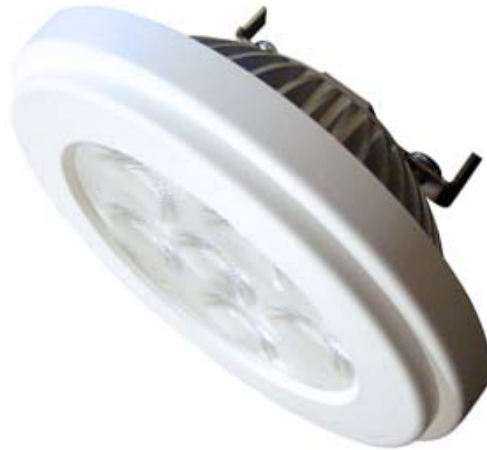
**Figure 2.2.** Con-Tech 10W LED AR111 Lamp

The two-story lobby space uses 75W AR111 halogen lamps because they deliver high intensity narrow beams that create visually dramatic patterns of light and shadow. Only one brand of lamps was submitted as replacements for this lamp type, a 10W LED AR111, 25° or 40° Flood distribution, warm (3000K) or neutral white (4000K) color. Participants preferred the warm color for this application, liked the color quality, but observed that the reported beam spread did not correspond to the submitted photometric report. (The actual beam spreads are 16° and 25°, respectively.) Although the intensity of light wasn't equivalent to the CBCP of the 75W AR111 halogen lamps used in the hotel lobby, the team

decided to try the narrower lamp to illuminate the lobby curtains. The color is somewhat cooler than the incumbent 3000K AR111 lamps (appearing pinkish from an increased blue content), but the new interior designer on the project expressed an interest in a cooler-color light for the lobby, so that could have been an advantage.

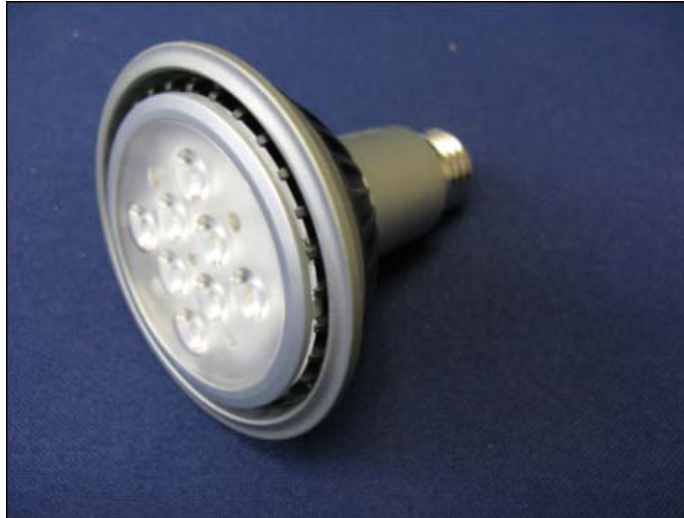
**Figure 2.3.** Philips 10W LED PAR30 Lamp

The request for samples of this lamp type had been sent out only a week before the Round 1 evaluation, so none of the lamps had arrived by the time the team evaluation took place. PNNL provided three samples of 10W LED PAR30 shortneck lamps separately. Their performance was not equivalent to the light output of the 75W PAR30 halogen lamps installed in conference level hotel corridors, but the team thought they might work as replacements for PAR30 lamps installed in conference room emergency lighting downlights. (Two downlights per conference room operate at full output, 24/7, as emergency lighting.) Unfortunately, they did not physically fit into the downlights. The team decided to try them in Registration Desk area downlights, along with other LED PAR30 lamps when they arrived.

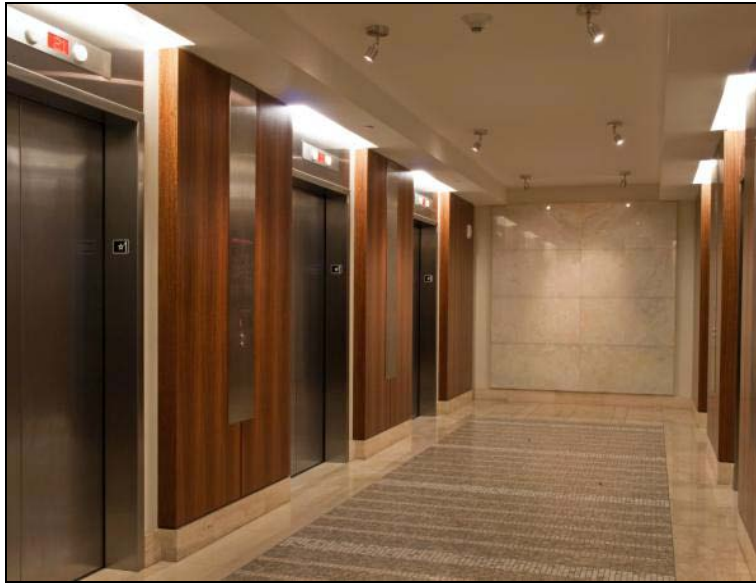
**Figure 2.5.** 1st Floor Elevator Lobby - Halogen Lamping (Dimmed). [www.kenricephoto.com](http://www.kenricephoto.com)

Higher illumination levels and improved uniformity are among the benefits immediately visible from the LED products on the first floor (Registration Desk Area and Elevator Lobby), when compared to the halogen lighting that had been routinely dimmed to very low levels.

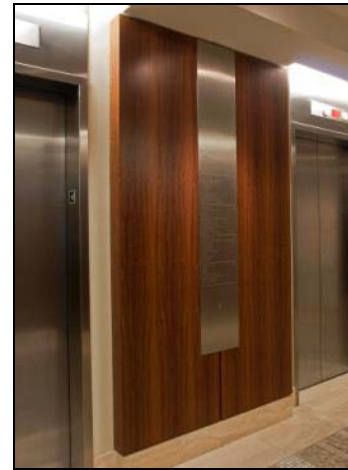
**Figure 2.4.** Closeup of elevator signage (Halogen). [www.kenricephoto.com](http://www.kenricephoto.com)

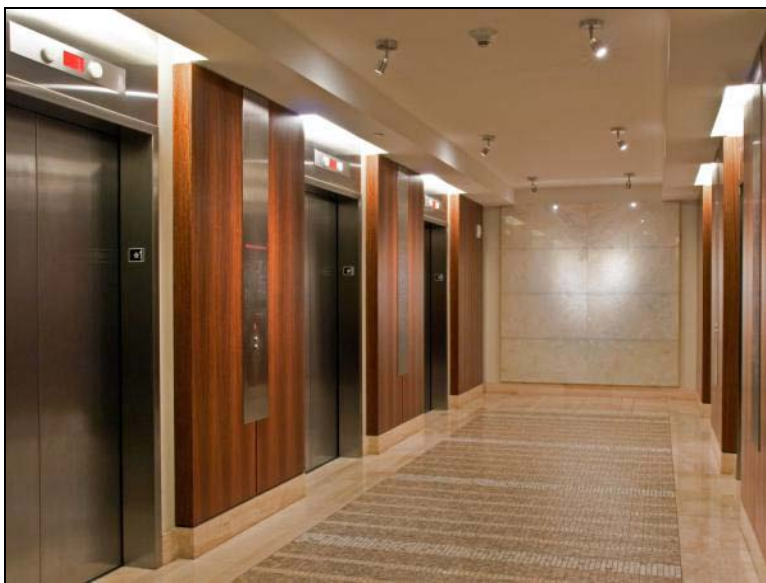
**Figure 2.7.** 1st Floor Elevator Lobby - LED Lamping (Undimmed). [www.kenricephoto.com](http://www.kenricephoto.com)

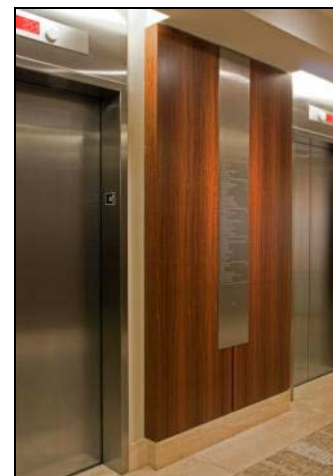
**Figure 2.8.** Closeup of elevator signage (LED). [www.kenricephoto.com](http://www.kenricephoto.com)

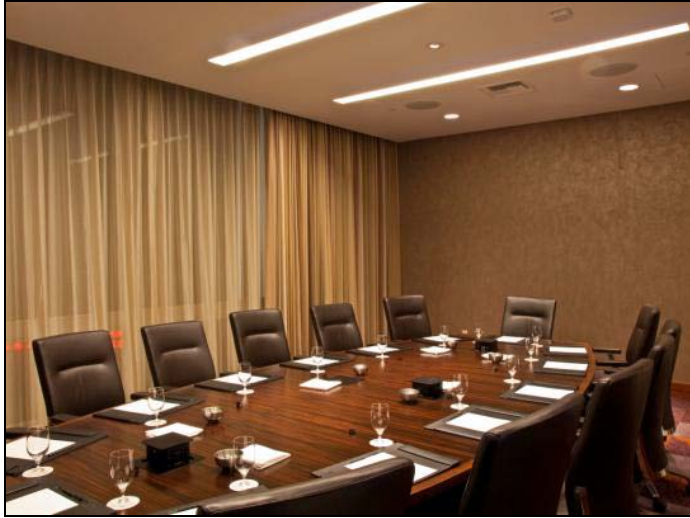
**Figure 2.9.** Conference room lighting with halogen downlights at far end.  
[www.kenricephoto.com](http://www.kenricephoto.com)

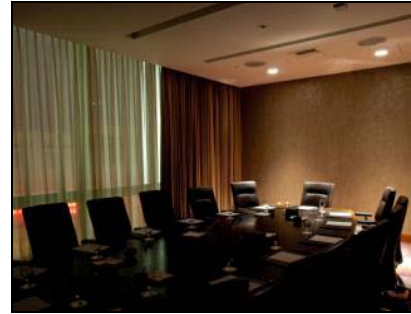
**Figure 2.10.** Conference room emergency lighting only – Halogen.  
[www.kenricephoto.com](http://www.kenricephoto.com)

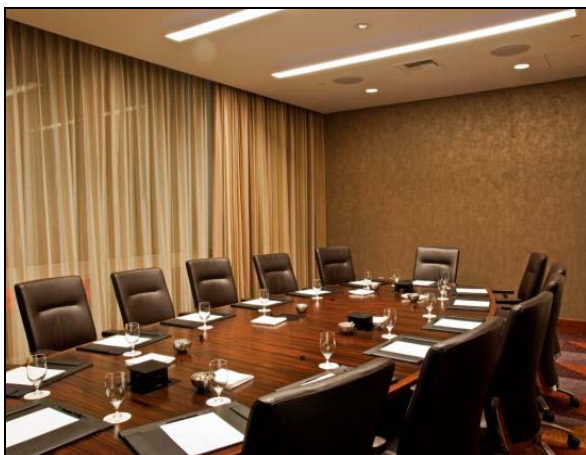
**Figure 2.13.** Conference room lighting with LED downlights at far end.  
[www.kenricephoto.com](http://www.kenricephoto.com)

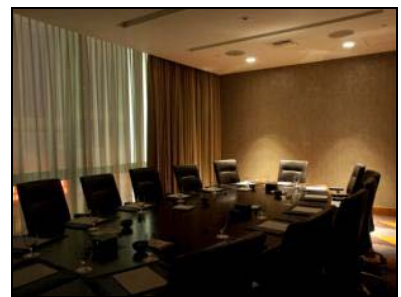
**Figure 2.12.** Conference room emergency lighting only – LED.  
[www.kenricephoto.com](http://www.kenricephoto.com)

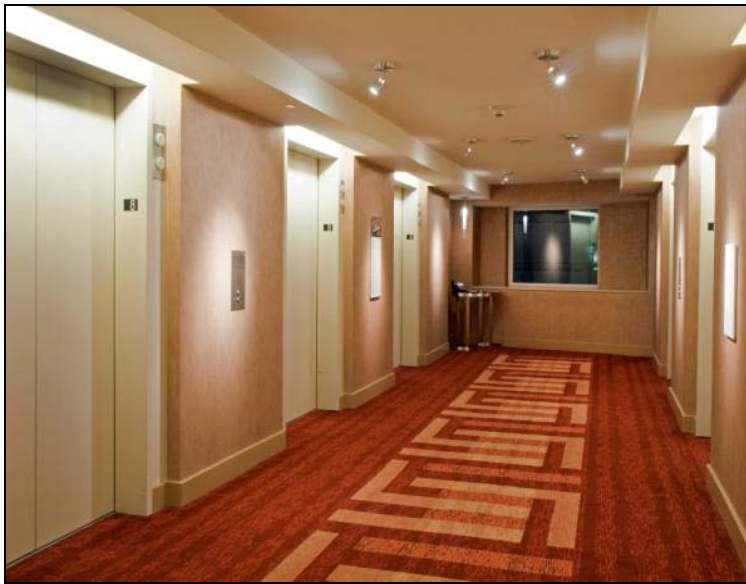
**Figure 2.14.** 8th Floor Elevator Lobby - Halogen Lamping.  
[www.kenricephoto.com](http://www.kenricephoto.com)

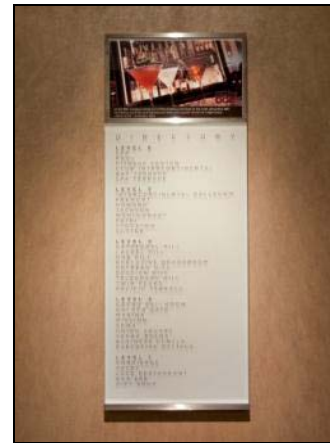
**Figure 2.15.** Closeup of elevator signage (Halogen).  
[www.kenricephoto.com](http://www.kenricephoto.com)

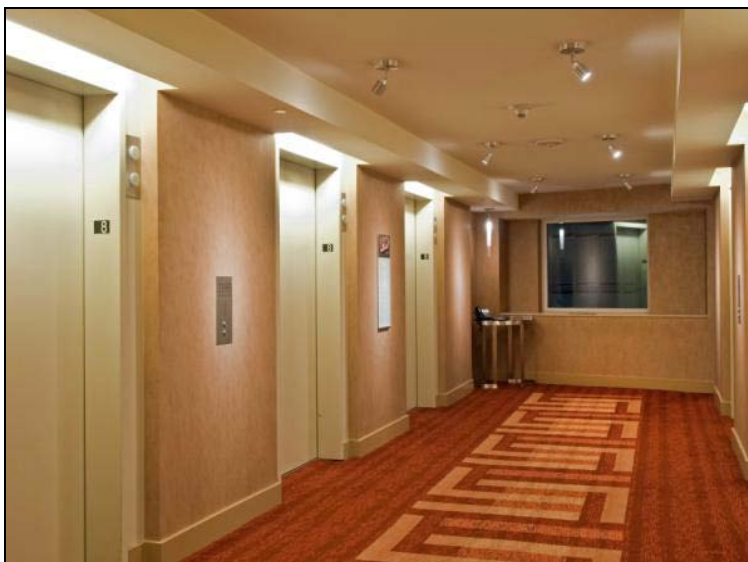
**Figure 2.18.** 8th Floor Elevator Lobby - LED Lamping.  
[www.kenricephoto.com](http://www.kenricephoto.com)

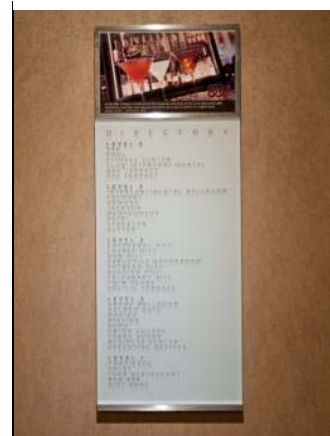
**Figure 2.16.** Closeup of elevator signage (LED).  
[www.kenricephoto.com](http://www.kenricephoto.com)

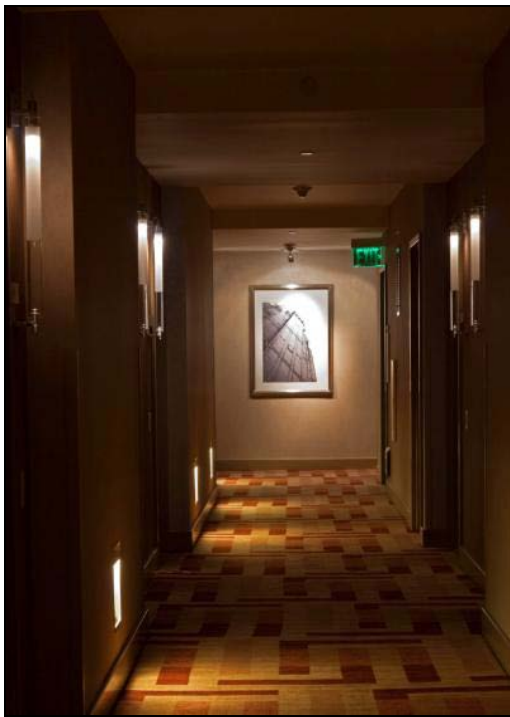
**Figure 2.19.** Guest Corridor Artwork Lighting (Halogen).  
[www.kenricephoto.com](http://www.kenricephoto.com)

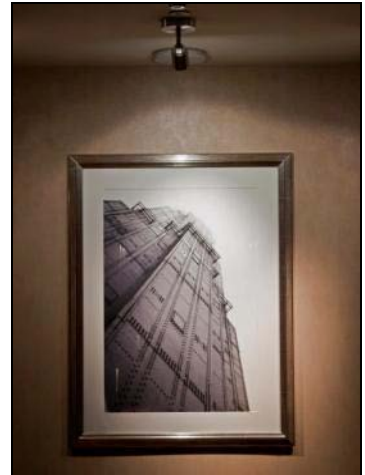
**Figure 2.20.** Closeup of guest corridor artwork (Halogen).  
[www.kenricephoto.com](http://www.kenricephoto.com)

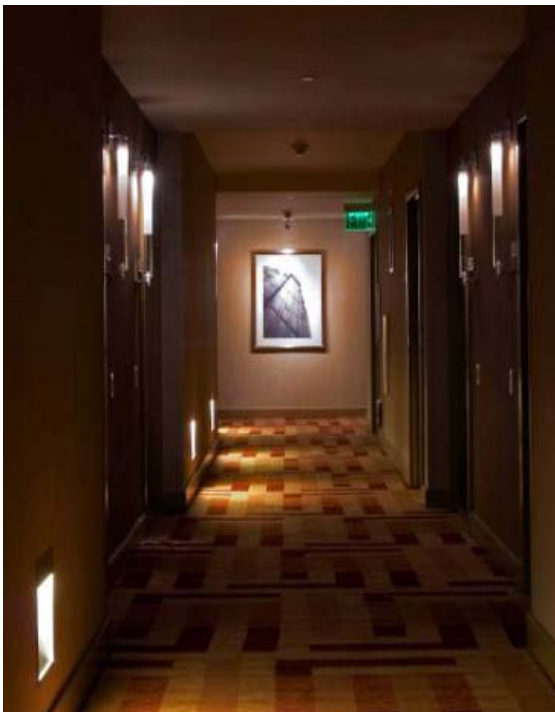
**Figure 2.22.** Guest Corridor Artwork Lighting (LED). [www.kenricephoto.com](http://www.kenricephoto.com)

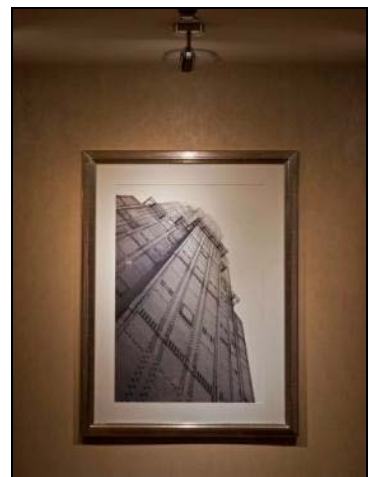
**Figure 2.23.** Closeup of guest corridor artwork (LED).  
[www.kenricephoto.com](http://www.kenricephoto.com)

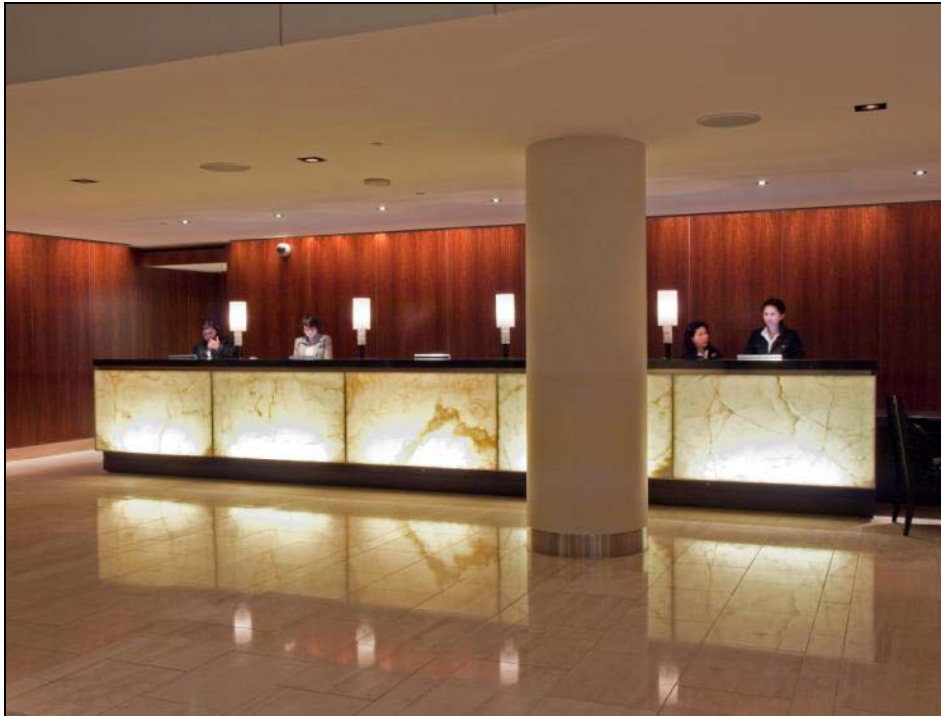
**Figure 2.24.** Registration Desk area with halogen accent and wall-grazing (onyx panels are backlighted with fluorescent lamps, and the pedestal lights use incandescent lamps). [www.kenricephoto.com](http://www.kenricephoto.com)

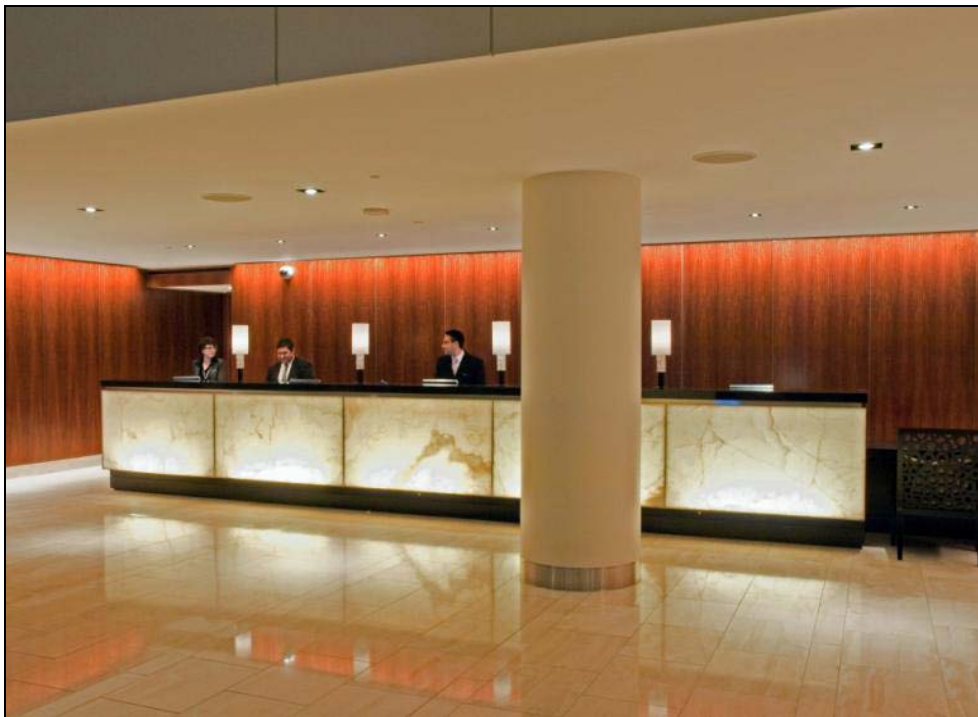
**Figure 2.25.** Registration Desk area with LED accent and wall-grazing (onyx panels are backlighted with fluorescent lamps, and the pedestal lights use incandescent lamps). [www.kenricephoto.com](http://www.kenricephoto.com)

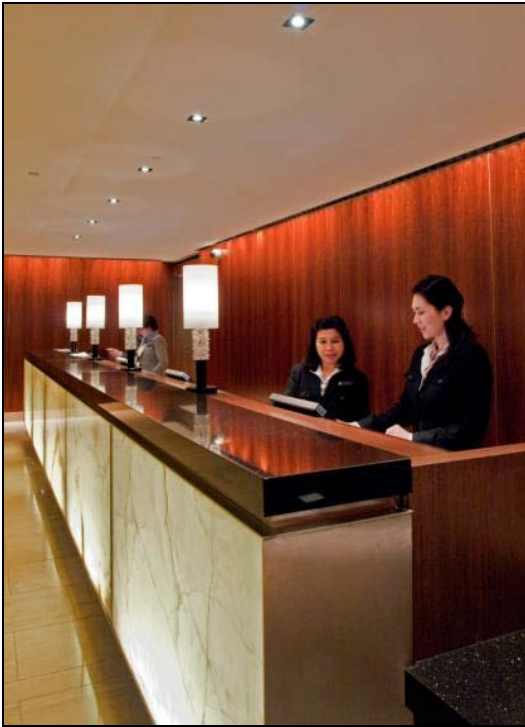
**Figure 2.26.** Registration Desk area counter showing overhead halogen accent lights. [www.kenricephoto.com](http://www.kenricephoto.com)

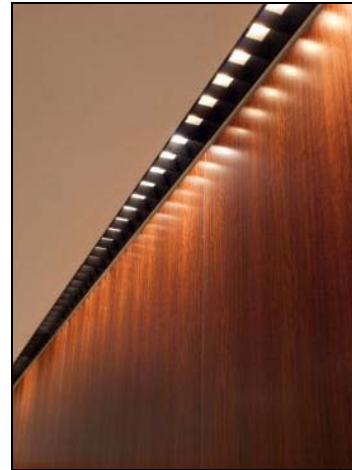
**Figure 2.27.** Closeup of wall grazing lighting (Halogen). [www.kenricephoto.com](http://www.kenricephoto.com)

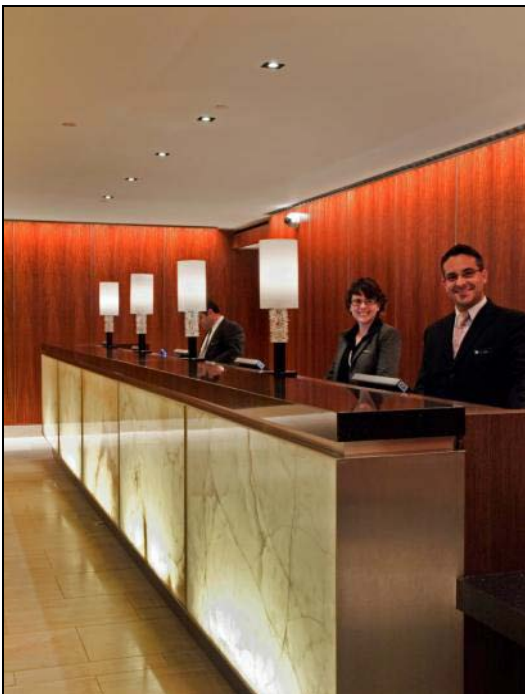
**Figure 2.27.** Registration Desk area counter showing overhead accent lights with LED replacement lamps. [www.kenricephoto.com](http://www.kenricephoto.com)

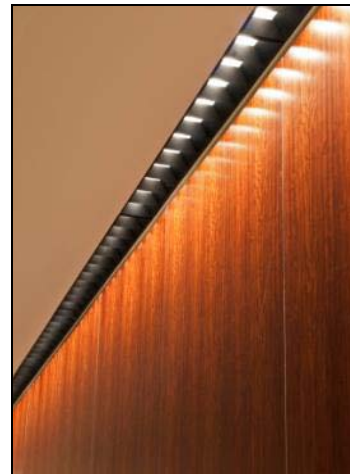
**Figure 2.28.** Closeup of wall grazing lighting (LED). [www.kenricephoto.com](http://www.kenricephoto.com)

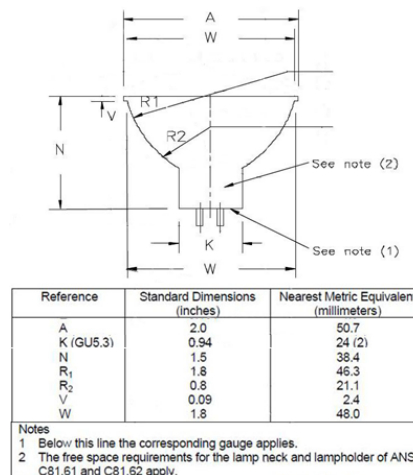
General Description: LED MR16 12V 10° NSP replacement lamp

Lamp Type: MR16

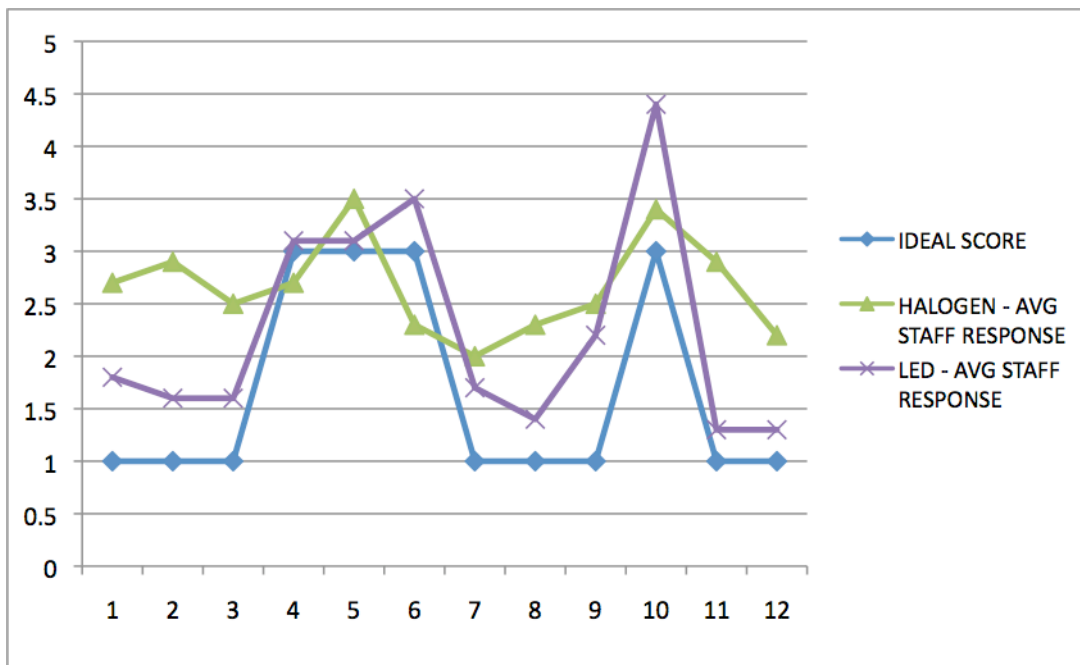
**Figure C.1.** Plot of Staff Responses to Before (Halogen) and After (LED) Lamping of the Registration Desk Area. Horizontal axis numbers correspond to survey question numbers, vertical axis to survey responses.
